Safety Communique

January, 2012

**MODELS: PISTON, ALL MODELS, ALL SERIALS;
KING AIR, ALL MODELS, ALL SERIALS;
AIRLINERS, ALL MODELS, ALL SERIALS**

SUBJECT: FLIGHT CONTROL CABLE SYSTEM INSPECTIONS

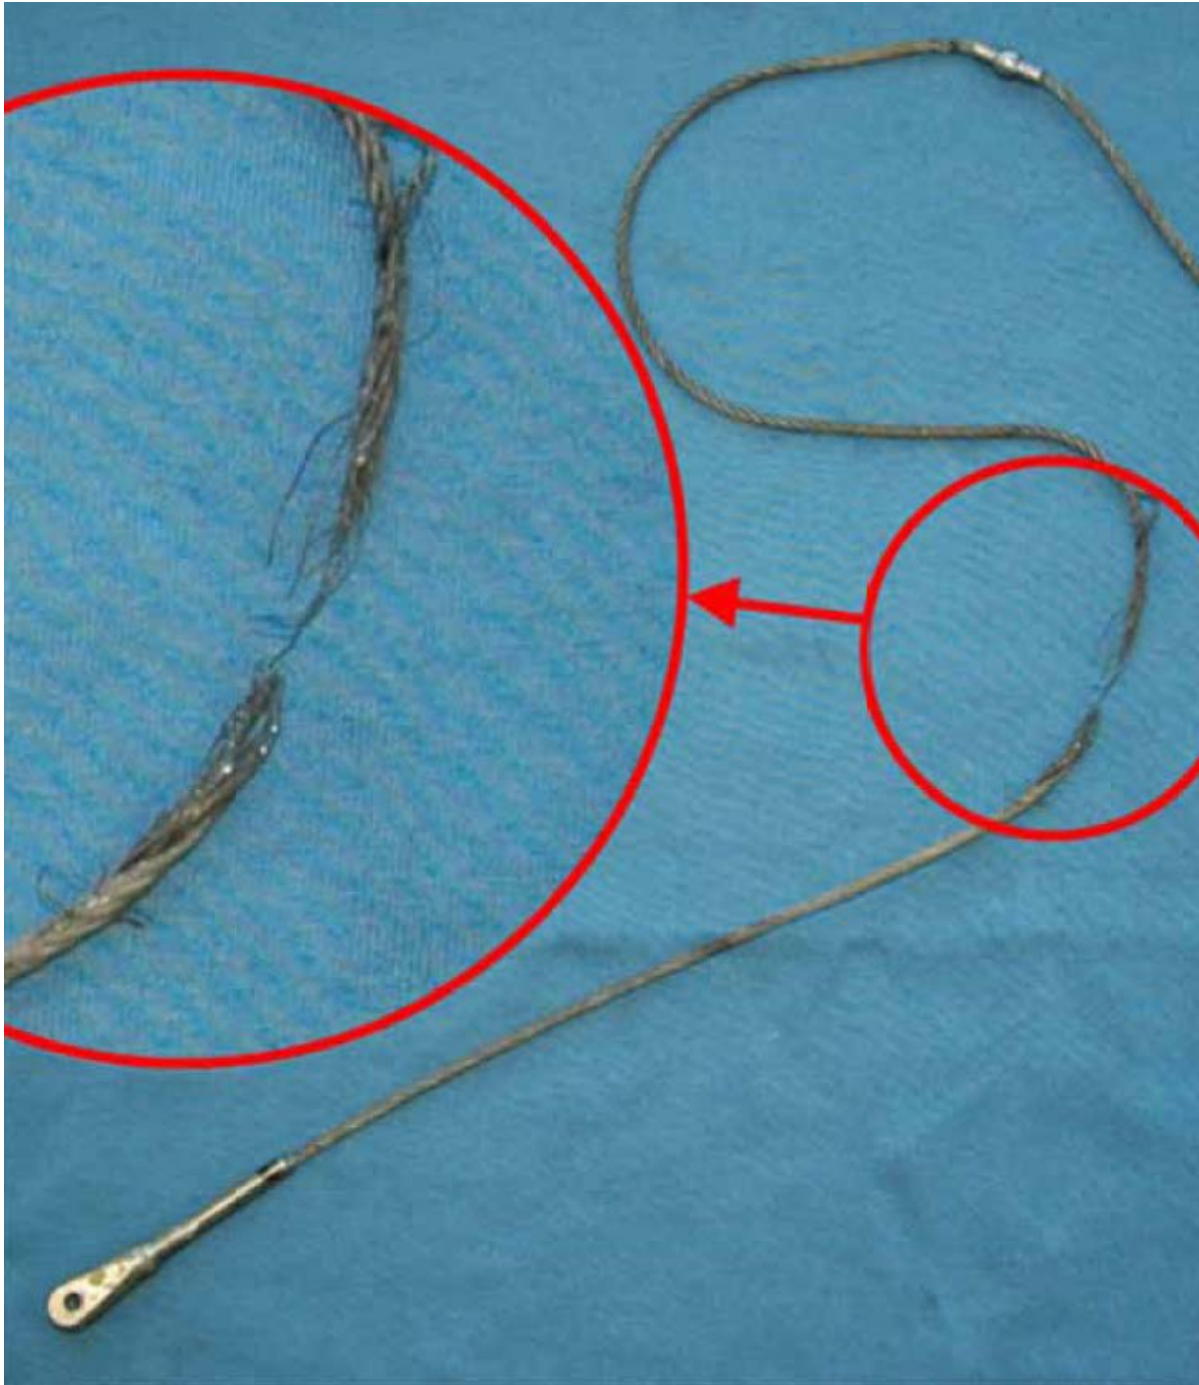
Frayed Elevator Control Cable
Figure 1

On December 4, 2011, HBC received a field condition report (FCR) from the owner/operator of a 1968 Bonanza Model E33 airplane with 4610 flight hours. A part number (P/N) 33-524000-63 forward elevator cable assembly was reported to have frayed to the point that only a few strands of cable remained intact. This discovery occurred just prior to takeoff. Figure 1 shows the frayed cable that was removed.

The CASA ADs provide instructions to inspect the forward elevator control cable assembly for wear, broken wires and corrosion. The ADs also mandate that any cable be removed and replaced if it had been in service for more than 15 years. The ADs were applicable to all “single pole” design control systems. The definition noted on the ADs reads as follows; “single pole” refers to the arrangement whereby the pilot’s control yokes are supported by a single shaft moving in and out of the instrument panel for elevator (pitch) control.

HBC recommends, when inspections are performed on flight control cable systems as instructed in the applicable airplane Shop or Maintenance Manual, that flight controls are operated through their full range so that cables move away from pulleys and all portions of the cables are exposed for inspection. Full control travel motion may require two persons, one to cycle controls and another to inspect cables during movement. Although the CASA ADs only affect the elevator control cable system, current HBC inspection guidelines apply to all flight control cables. Anywhere a cable is not visible, the flight controls should be manipulated so 100% of all cables can be inspected. During the inspection process, the inspecting individual shall also examine the cable runs for incorrect routing, fraying, twisting, or wear at fairleads, pulleys, anti-abrasion strips and guards. Inspecting individuals shall ensure there is no interference with adjacent structure, equipment, wiring, plumbing, and other controls. Cable systems shall not exhibit binding through full travel, and proper tension of cables shall be maintained.

HBC reminds owners/operators of the importance of maintaining corrosion preventive compound on control cables and applying proper lubricants to control cable system components as defined in the applicable airplane Shop or Maintenance Manual. Replace control cables showing evidence of corrosion.
