SERVICE BULLETIN

TITLE: STABILIZERS - INSPECTION/REPLACEMENT OF ELEVATOR BALANCE WEIGHT ASSEMBLIES

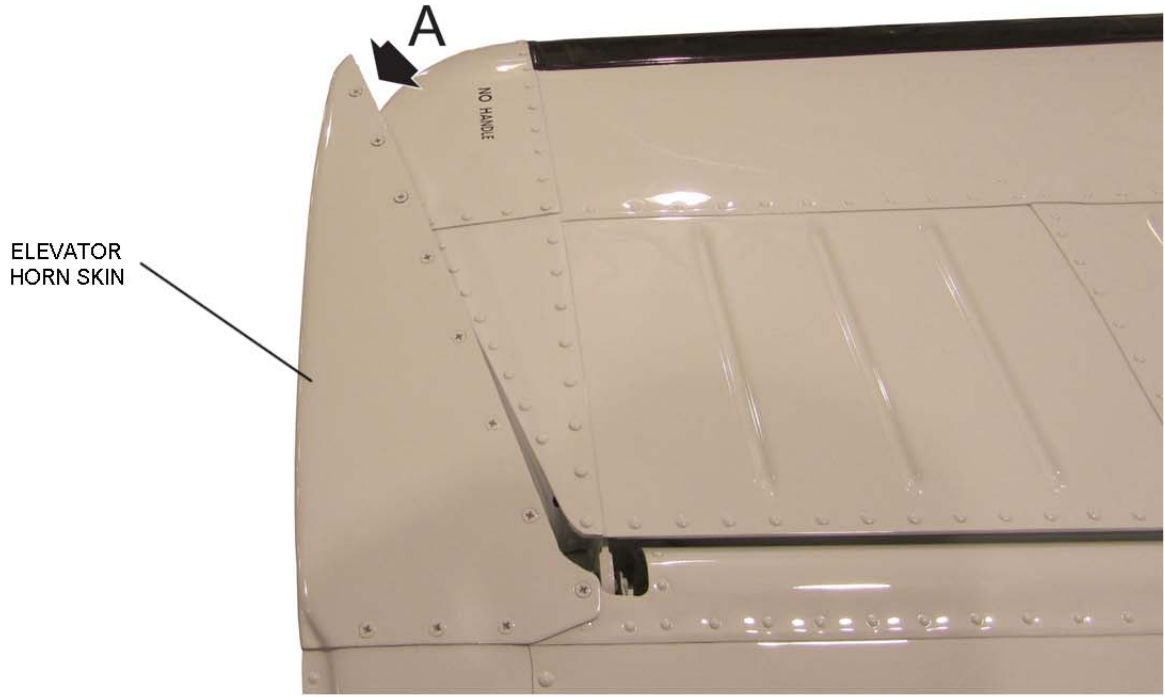
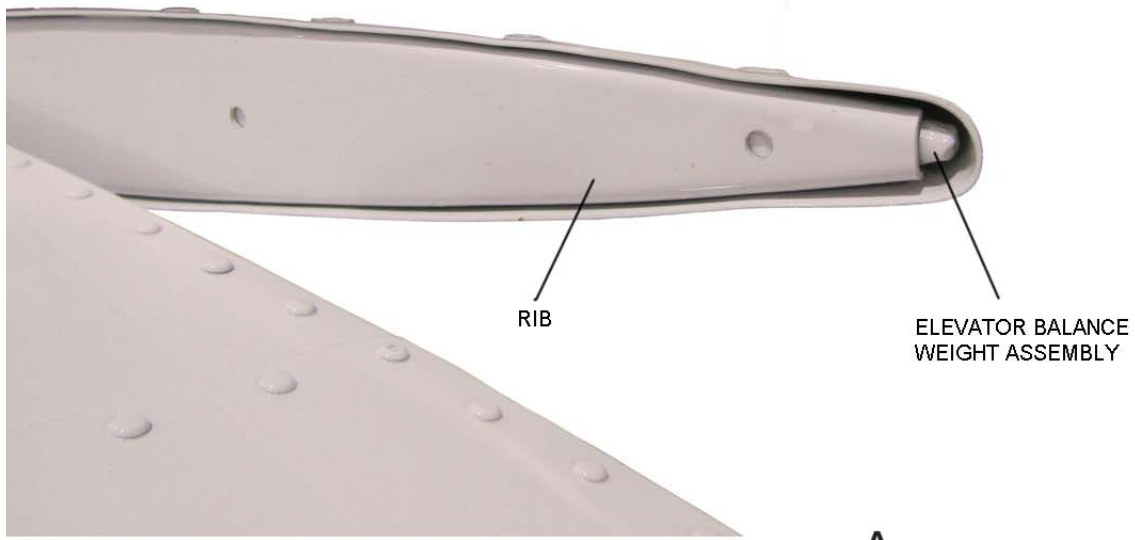
Inspection of Elevator Balance Weight Assembly
Figure 2

- (3) Visually inspect to determine if the existing elevator balance weight assembly is in position and protruding from the edge of the rib. In addition, verify that the elevator balance weight assembly attachment screws on upper and lower surfaces are secure and the installation holes show no sign of discoloration. Refer to Figure 1 and Figure 2.

- (7) Use the screws and associated attachment hardware that were retained in Step (4) to install the applicable new elevator balance weight assembly. **Note:** New hardware may be used as necessary, as defined in Paragraph 2.C.2. The installed elevator balance weight assembly shall protrude from the rib as shown in Figure 2.

- (b) If the existing elevator balance weight assembly has become dislodged, the attachment screws are not secure, or the installation holes show signs of discoloration, proceed to Step (4).

- (5) Remove the existing elevator balance weight assembly from its position under the elevator horn skin.
- (6) Weigh the removed elevator balance weight assembly to determine which replacement elevator balance weight assembly shall be installed. Part numbers apply to the weight of the removed elevator balance weight assembly as follows:

Elevator balance weight assembly, P/N 96-610022 = 3.4 +/- 0.10 LB
Elevator balance weight assembly, P/N 96-610022-5 = 3.55 +/- 0.10 LB
Elevator balance weight assembly, P/N 96-610022-7 = 3.9 +/- 0.10 LB
Elevator balance weight assembly, P/N 96-610022-9 = 4.10 +/- 0.05 LB
