Safety Communique

January, 2012

**MODELS: PISTON, ALL MODELS, ALL SERIALS;
KING AIR, ALL MODELS, ALL SERIALS;
AIRLINERS, ALL MODELS, ALL SERIALS**

SUBJECT: FLIGHT CONTROL CABLE SYSTEM INSPECTIONS

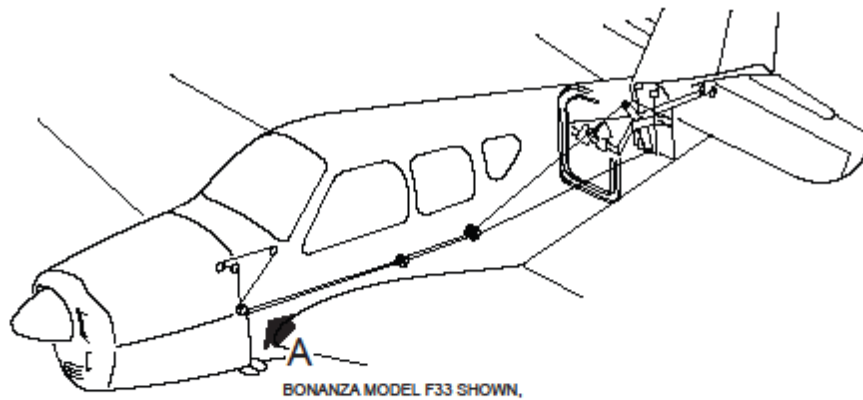
Frayed Elevator Control Cable
Figure 1

On December 4, 2011, HBC received a field condition report (FCR) from the owner/operator of a 1968 Bonanza Model E33 airplane with 4610 flight hours. A part number (P/N) 33-524000-63 forward elevator cable assembly was reported to have frayed to the point that only a few strands of cable remained intact. This discovery occurred just prior to takeoff. Figure 1 shows the frayed cable that was removed.

The CASA ADs provide instructions to inspect the forward elevator control cable assembly for wear, broken wires and corrosion. The ADs also mandate that any cable be removed and replaced if it had been in service for more than 15 years. The ADs were applicable to all “single pole” design control systems. The definition noted on the ADs reads as follows; “single pole” refers to the arrangement whereby the pilot’s control yokes are supported by a single shaft moving in and out of the instrument panel for elevator (pitch) control.

HBC reminds owners/operators of the importance of doing a thorough flight control cable system inspection. Some areas of control cable routing require a deliberate inspection effort due to location and cable routing between pulleys. Refer to Figure 2 for an illustration of a
